## RAPID ANALYSIS REPORT

# Scientific Anatomy of the 26 August 2026 Bhotekoshi Flash Flood

IRDR Young Scientist's rapid analysis of the flash flood event

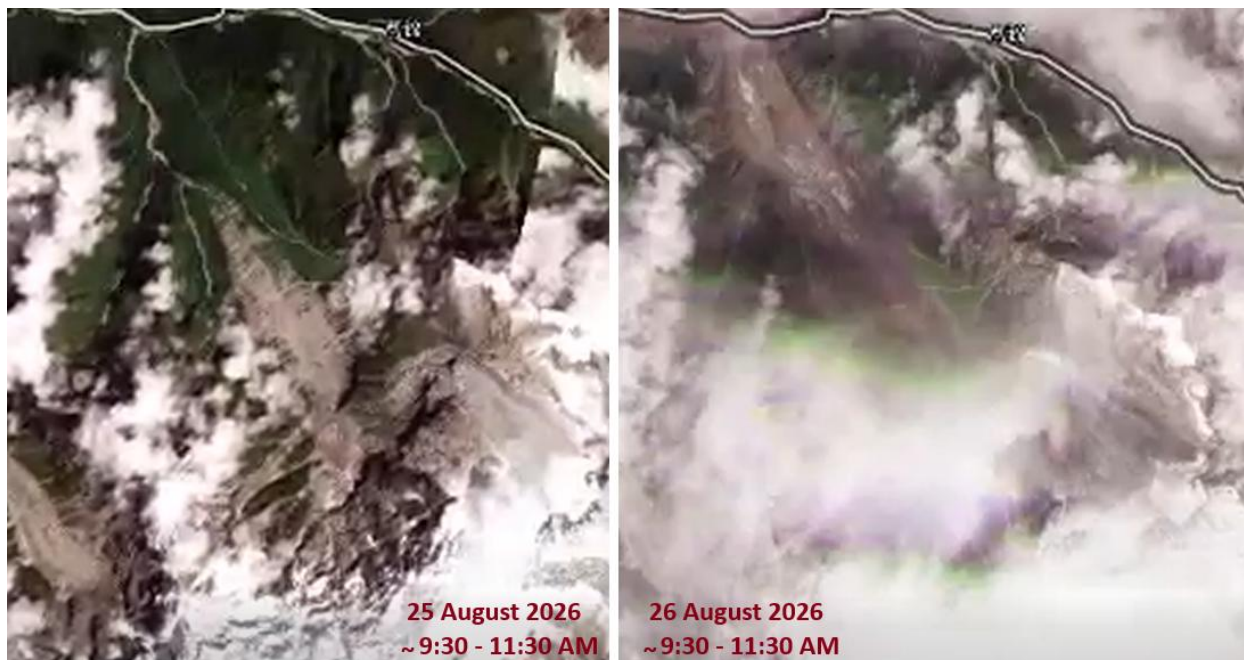
*Image: Satellite image of the ice/rock avalanche location from 25 and 26 August 2026 (Source: Planet).*

The combined analysis of satellite imagery, rainfall and discharge data indicates that the initial failure likely occurred around 1:00-2:00 p.m. on 25 August. A large ice-rock-soil mass likely descended from approximately 5,000 m toward the river at around 3,000 m, where it temporarily blocked the river and formed a natural dam. During the fall, the ice was likely broken into smaller pieces and mixed with soil, rock and debris. The blockage remained for approximately 18-19 hours, while water accumulated behind it. Some of the trapped ice may have melted during this period. While frozen ice may initially have helped hold the soil and debris together, its melting could have loosened the material, increased water infiltration and promoted internal erosion, progressively weakening the blockage. The analysis also identified mild rainfall within the Mala River watershed, which continuously contributes flow to the Bhotekoshi River from the west near the Nepal-China border. Continued inflow from the Mala River and other tributaries would have maintained downstream flow even while the upstream Bhotekoshi channel was blocked. This may have masked the effect of the blockage in downstream river conditions, making the developing

natural dam difficult to recognize from downstream. This interpretation is also supported by observations from Planet satellite imagery.

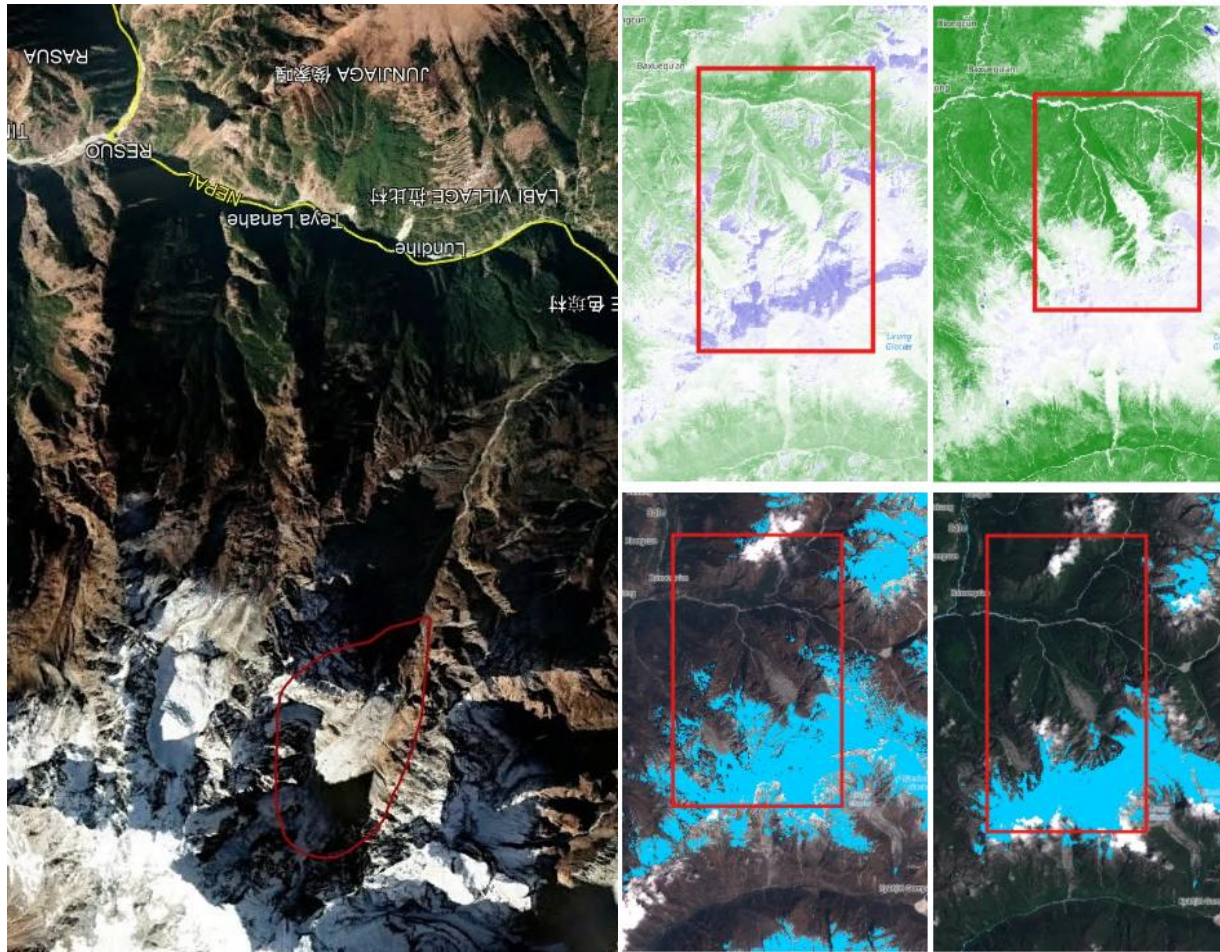
*Image: Satellite image (left), normalized difference water index (top right), and normalized difference snow index (bottom right) from 12 March and 12 August (Source: Google Map and Copernicus, accessed at 11:00 AM, 26 August 2026).*

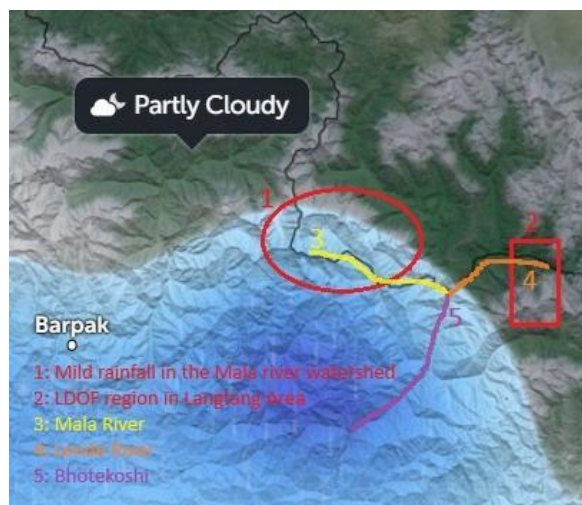
Hourly Discharge Measurement in Bhotekoshi River in Rasuwagadhi

The Bhotekoshi discharge station at Rasuwagadhi (Station Index No. 446.22) showed no clear increase immediately before the initial failure. This is consistent with the interpretation that the major flood was generated by the later breach rather than by a sudden rainfall-driven increase in flow. Several unusual features in the discharge record require further examination and are discussed in the downstream propagation section.

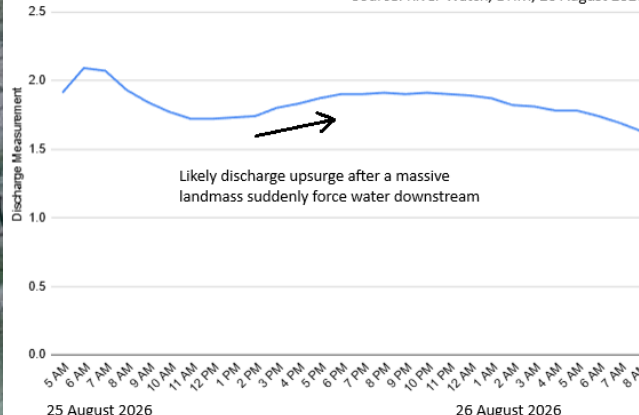
Image: Rainfall map for 25 August 2026 (left), and discharge measurement in the Bhotekoshi River in Rasuwagadhi (right) (Source: Department of Hydrology and Meteorology, Nepal).

From the outset, available rainfall and river data showed no heavy or sufficiently localized rainfall capable of explaining the magnitude and sudden onset of the flood. This prompted a rapid investigation by the IHRR ICoE of the IRDR, involving IRDR Young Scientists from Nepal with support from scientists in China. Within a few hours, the team reviewed satellite observations, weather information and river data and identified a suspected slope-failure area around Deding in the Langtang region. Pre-event satellite observations also showed changes in snow and ice conditions around the suspected source area, including snow retreat and changes in snow accumulation. As pre-event and post-event satellite imagery became available, the suspected location closely matched the observed source area, supporting the initial assessment.

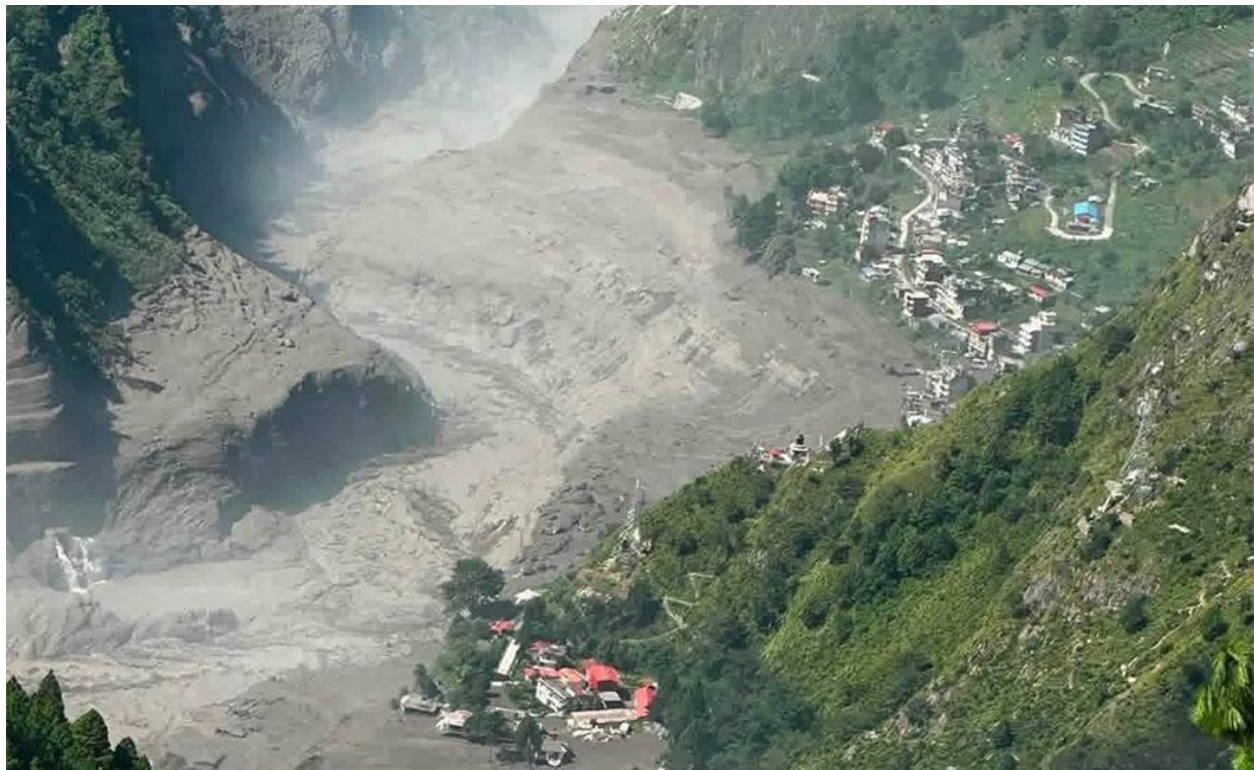
**Photo source:** <https://www.onlinekhabar.com/2026/08/2003997/floods-damage-431-megawatt-power-plant>

The disaster also produced major cascading impacts on the energy and critical infrastructure sectors. Preliminary Nepal Electricity Authority information indicated that 748 MW of hydropower capacity was affected, comprising 354 MW from operational projects and 394 MW from projects under construction. Several hydropower facilities, including Rasuwagadhi, Chilime and Trishuli-3A, were reported damaged, along with associated transmission and distribution infrastructure. The 220 kV Trishuli 3B Hub Substation was completely destroyed, while multiple transmission lines were disrupted. These losses affected electricity generation, transmission and distribution beyond the immediate flood corridor. The combined destruction of roads, bridges, customs infrastructure, hydropower facilities, communications and commercial centres demonstrates that the event developed into a multi-sector cascading disaster, in which a sudden source-area disturbance propagated through a highly exposed mountain corridor and produced simultaneous impacts on human settlements, border trade, transport, energy, tourism, communications and emergency-response capacity.
